TP 185E
Issue 4/2008

AVIATION SAFETY LETTER

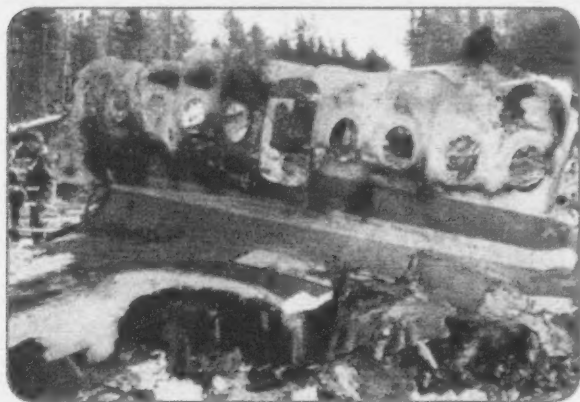
Dryden, Ont., March 10, 1989

The threat is very real! Some of you will remember the Dryden accident. For those who don't, the March 10, 1989, accident of a Fokker F28-1000 claimed the lives of 24 people (see photo, above). As a result of that accident, a commission of inquiry, led by The Honourable Virgil P. Moshansky, was instituted. Public hearings lasted 20 months and 166 individuals were interviewed. Thousands of pages of transcripts and evidence were condensed into a four-volume report. Typical of many accidents, there were a number of causal

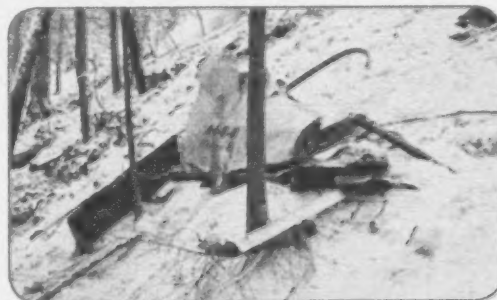
1. Galling on the engine-cooling fan taper-fit joint within the previous few hours of flight operations introduced vibration to the belt-drive system, which in turn caused the misalignment of the belts within the sheave grooves and led to two vee-belts running off the sheaves in flight.
2. The sudden loss of vee-belt tension caused the remaining two vee-belts on the driving sheave to slip, leading to a rapid loss of main rotor RPM. This, in turn, prevented the pilot from avoiding the trees and led to a collision with the terrain and the destruction of the helicopter.
